OXIDE THICKNESS MEASUREMENTS AND CHARACTERIZATION OF TWO Zr-2.5Nb PRESSURE TUBES OF EMBALSE NUCLEAR POWER PLANT

R. Bordoni, A.M. Olmedo*

Departamento Química de Reactores, Gerencia Química, Comisión Nacional de Energía Atómica. Avda Gral Paz 1499 (B1650KNA) San Martín, Buenos Aires; Argentina

ABSTRACT

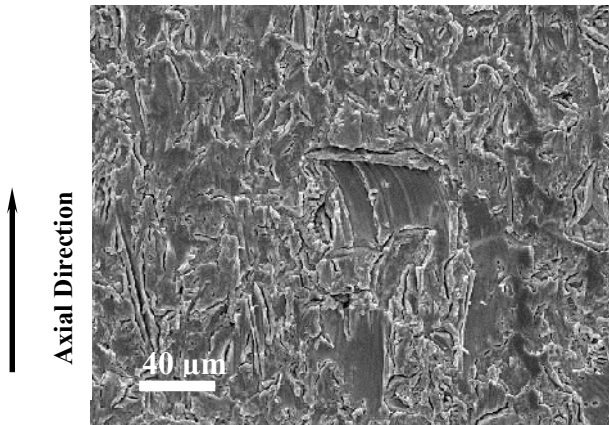
The visual examination of the samples cut from the PTs showed that the inside surface of them were covered with an adherent black oxide. Figures 3 (a) and (b) show that the oxide morphology of PTs inside surface have topographical features typical of sandblast surfaces.

Fig. 3 (a). Typical oxide morphology of the inside surface. Sample taken at 12 o'clock, 0.3 m axial position from the inlet of PT A-14.

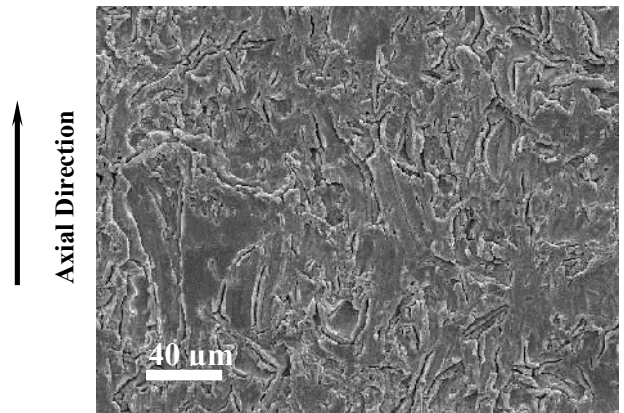
Fig. 3 (b). The same of Fig. 3(a) taken at 3 o'clock position.

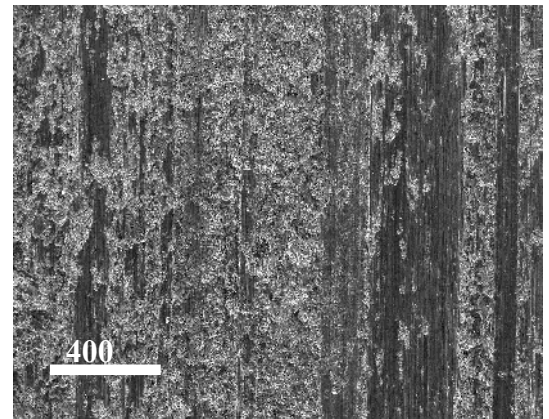
A representative oxide morphology of the inside surface of a sample at 6 o'clock location is shown in Figure 4. Figure 4 (a), presents clearly the axial scratches produced at the bottom of the tube during fueling caused by the fuel bundle bearing pads. The oxide morphology at the side zones of the scratch marks left by the bearing pads is similar to the oxide in others o'clock locations, Figure 4 (b). These scratch marks, are slight and innocuous.

Fig. 4 (a) Typical oxide morphology of the inside surface taken at 6 o'clock, 0.3m axial position of PT A-14 showing fueling scratches

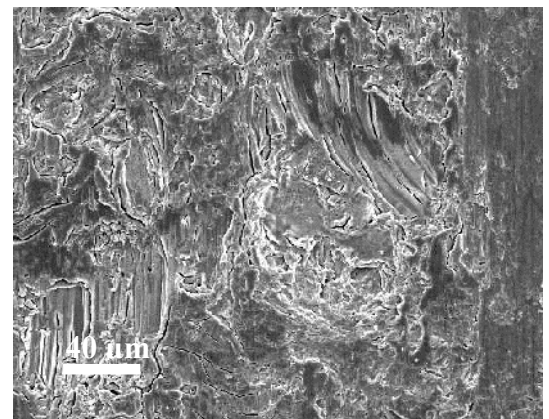
Fig. 4 (b) Magnification of Figure 5(a)

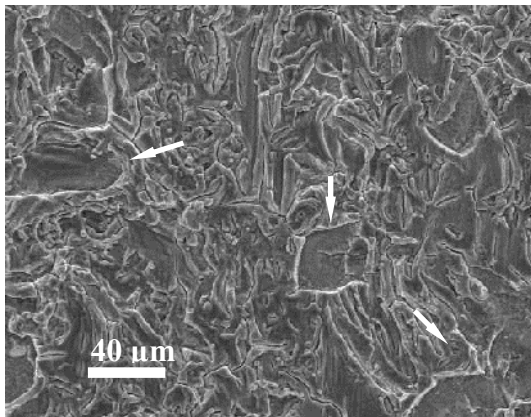
The inside surface oxide at other positions of both PTs presents a similar topography and appearance than those shown in Figures 3 and 4. A small number of spalling areas were observed in the first half part of the PTs, at 0.3 and 3.1 m axial locations. The density of spalling areas increases slightly in the second half of the tubes, at 5.1 and 5.8 m axial locations, being larger in the central fuel channel than in the peripheric one. These features can be seen in Figures 5 and 6.

Fig. 5. Typical oxide morphology of the inside surfaces. Micrograph was taken at 12 o'clock and at 5.1 m from the inlet of PT A-14. Arrows indicate some spalling areas.

In all of the cross sections of the samples studied, neither the small spalling zones nor any other defect affect the protective character of the oxide film since in all the specimens, there was always at least 5-6 μm of adherent,

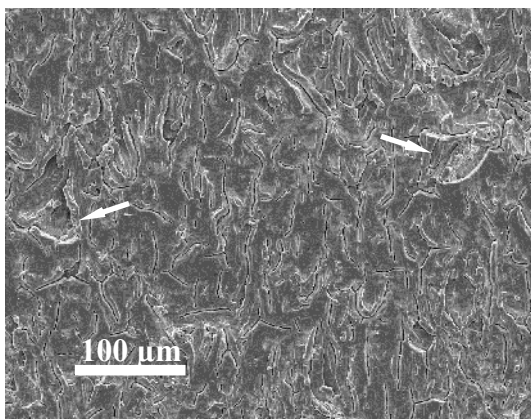
Fig. 6. Typical oxide morphology of the inside surfaces. Micrograph was taken at 12 o'clock and at 5.7 m from the inlet of PT L-12. Arrows indicate some spalling areas.

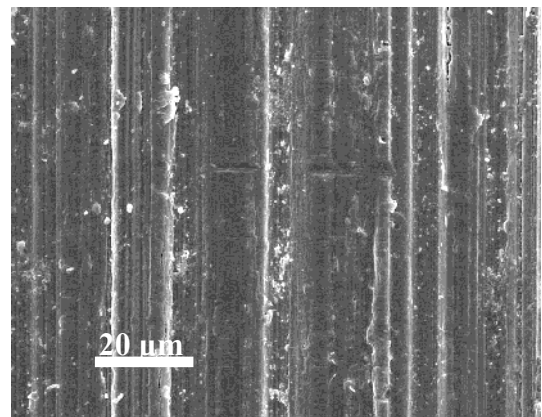
The visual appearance of the oxide on the outside surface was black, compact and was more reflective than that of the inside surface. Figure 7 shows a typical appearance of the outside surface oxide. This micrograph shows that the oxide film replicates the original outside tube surface. Small microcracks are also seen following the direction of the original grinding marks of the original external surface of the pressure tube. This is a common feature of the oxide of all PTs that do not affect the protective character of the oxide layer due to the small depth of these microcracks.

Fig. 7. Typical oxide morphology of the outside surface. This micrograph was obtained from a sample of PT L-12 at 12 o'clock and 5.8 m position from inlet.

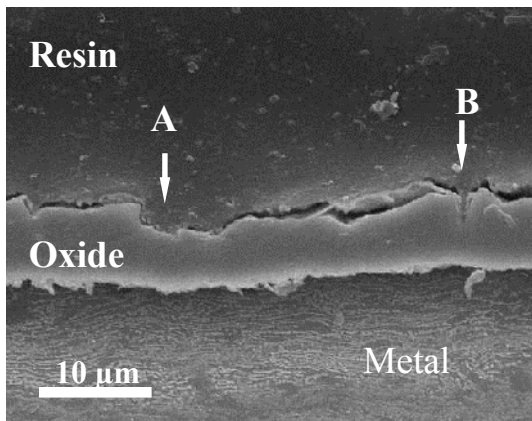
Figures 8 and 9 show the cross section micrographs of a sample at 12 o'clock located at 0.3 m position and at 6 o'clock located at 5.8 m position from the inlet of the peripheric and central PTs respectively. The micrographs show that the oxide edge corresponding to the oxide/coolant interface is very irregular in accordance with the oxide morphology showed in Figures 3, 4 and 5.

The cross section micrographs show a compact oxide layer with a few small microcracks perpendicular to the surface penetrating up to a distance smaller than half of oxide thickness. It can also be seen small areas of microspalling already mentioned, but the oxide non damaged and protective is always present at the metal/oxide interface. Other characteristic in these micrographs is the presence of lateral microcracks, that are typical of the zirconium oxide layers [7,14, 15, 16].

Fig. 8. Cross section of the inside surface sample from PT A-14 taken at 12 o'clock and 0.3 m position from the inlet.

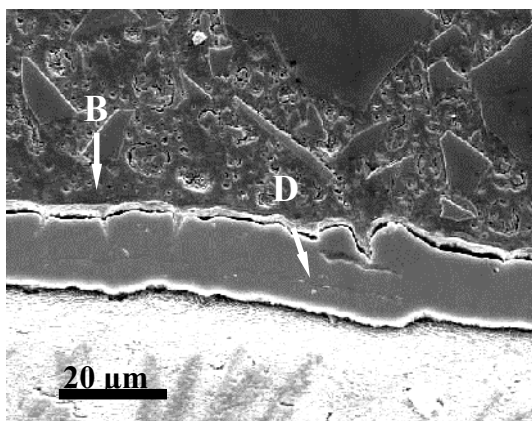
Fig. 9. Cross section of the inside surface sample from PT L-12 taken at 6 o'clock and 5.7m position from the inlet.

Arrow A indicates a small zone of spalling, arrows B show microcracks perpendicular to the surface and arrow D shows parallel microcracks.

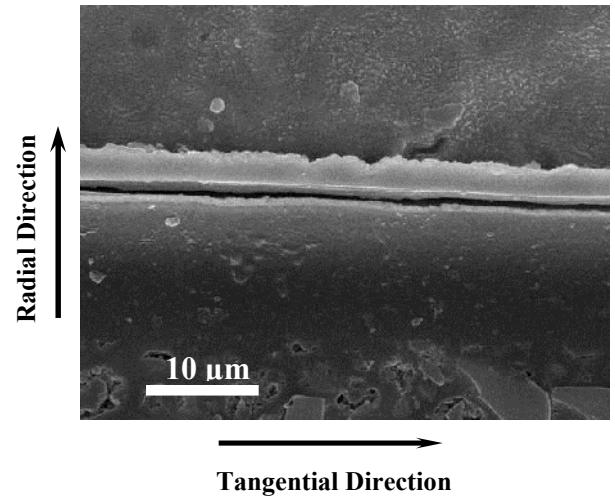
Figures 10 and 11 show cross section micrographs of samples from the outside surface oxide. The differences in the aspect of the oxides shown in these two micrographs are a consequence that the samples were prepared in two different planes.

Fig.10. Cross section showing the external oxide appearance of PT A-14 taken at 12 o'clock and 5.8 m position from the inlet. The plane of the micrograph corresponds to a radial-tangential plane.

Figure 10 shows the cross section on the radial-tangential plane that contains the original grinding marks of the PT, while Figure 11 shows the radial-axial plane that is perpendicular to the grinding marks. The orientation of the last cross section was prepared to analyze small defects that were seen in the morphological observations shown before. In Figure 10 no defects are seen and the oxide edge at the oxide/annulus gas interface is also regular. It can be seen that oxide defects (like oxide loss or broken oxide) are smaller than half the oxide thickness and that the oxide appearance is adherent, and compact.

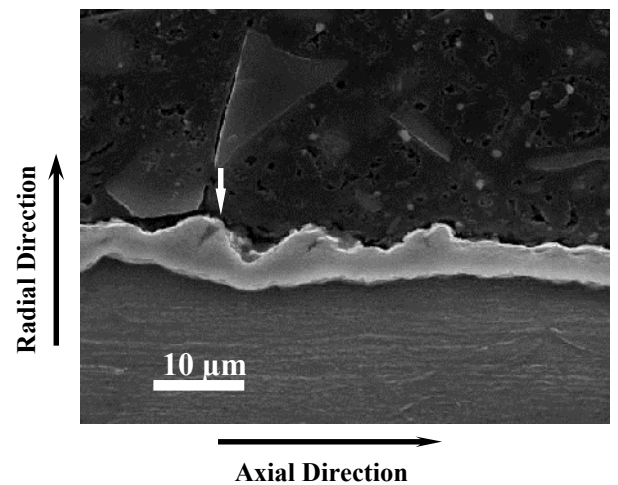
Fig. 11. Cross section showing the external oxide appearance of PT L-12 taken at 6 o'clock and 5.8 m position from the inlet. The plane of the micrograph corresponds to axial-radial plane.

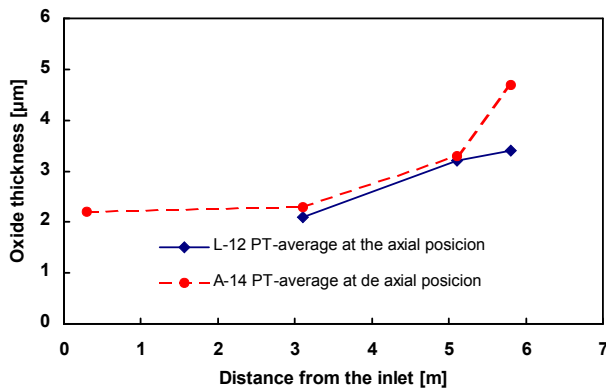
Figure 12 plots the axial profile of the average oxide thickness of the external surface for A-14 and L-12 pressure tubes. The oxide thickness at 0.3 m location from the inlet of PT L-12 was not measured. This Figure indicates that the oxide thickness increases slowly with the distance from the inlet end of the tube. The thickness varies between 2 to 5 μm for PT A-14 and between 2 to 3.5 μm for PT L-12. These values are similar to those reported by Warr *et al* [12] for the outside surface oxide of pressure tubes removed from CANDUs reactors.

Fig. 12. Axial profile of the outside oxide thickness of PT A-14 and PT L-12.

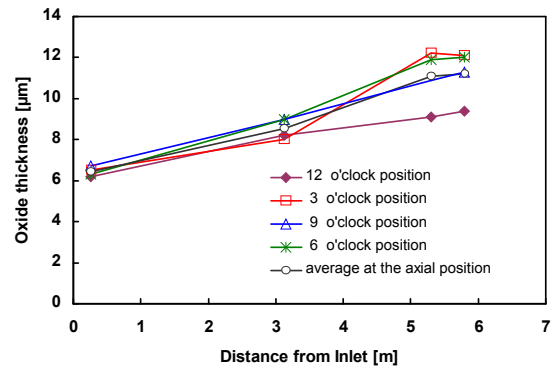
Figure 13 plots the axial profile of the average oxide thickness at 3, 6, 9 and 12 o'clock positions of the internal surface for A-14 pressure tube and also depicts

the average oxide thickness for each axial position. Figure 13 shows the same for L-12 pressure tube. These Figures indicate that the oxide thickness increases with the distance from the inlet end of the tube. As expected, the oxide thickens with increasing the coolant temperature along the tube. In the first two axial locations, the oxide thickness changes only slightly with changing the o'clock position, while the oxide thickness at 12 o'clock position is smaller in the last two axial locations. Warr *et al.* [12] reported similar oxide thickness differences at 6 and 12 o'clock positions for some pressure tubes that were in service during 10.3 EFPY in Pickering 3 NPP. These authors indicated that the greater oxide thickness found at 6 o'clock position should be associated with the higher temperature in this position compared with that at 12 o'clock position.

Fig. 13. Axial profile of the internal oxide thickness at 12, 3, 9 and 6 o'clock position and the average in axial location of PT A-14.

The oxide thickness of A-14 tube varies along it approximately between 6 to 12 μm and its average oxide thickness is 11 μm at 5.8 m axial location: In L-12 tube the oxide thickness varies approximately between 7 to 15 μm along it and its average oxide thickness is 13 μm at 5.8 m axial position. As the pressure tubes operated during 9.9 EFPY, the average corrosion rate was 1.2 and 1.5 $\mu\text{m}/\text{EFPY}$ respectively. These values of corrosion rates are within the range of the values reported by Warr et al [17] for pressure tubes removed from Bruce A and other CANDUs 6 reactors.

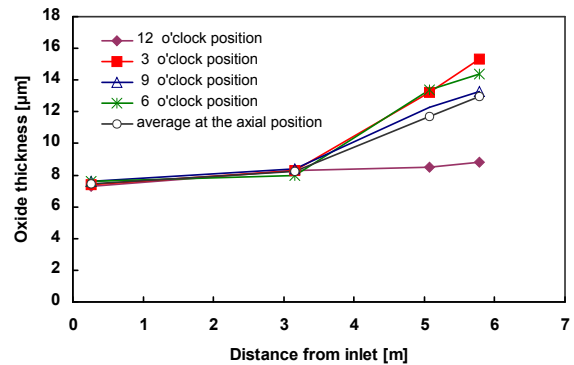
Fig. 14. Axial profile of the internal oxide thickness at 12, 3, 9 and 6 o'clock position and the average in axial location of PT L-12.

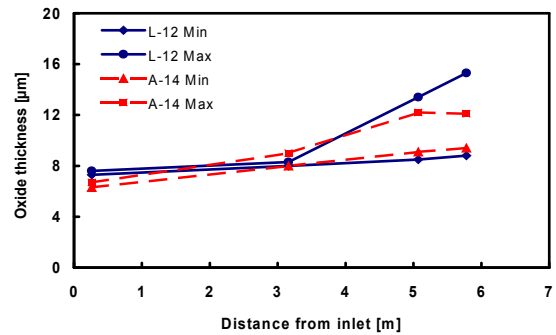
The range of oxide thicknesses of the inside surface at different axial locations for both tubes is compared in Figure 15. This Figure shows that the range of oxide thicknesses is similar for both tubes and the maximum thickness is slightly greater for the PT L-12 at 5 - 6 m location from the inlet of the PT.

These results should indicate a weak dependence of the corrosion rate with the fast neutron flux for this range of neutron flux and for the residence time of the tubes in the reactor. Warr et al. [17] have also indicated a weak dependence of the corrosion rate with the fast neutron flux.

Fig. 15. Comparison of the range of oxide thicknesses of the inside surfaces for A-14 and L-12 PTs
