Failure Analysis of Fixation Devices Used in Broken Bones

Mariana H. Staia*, Julio C. Machado *, Eli S. Puchi*, Sonia Camero* and Rafael Paiva** * School of Metallurgy and Materials Science, Faculty of Engineering, Central University of Venezuela, Apartado 49141, Caracas 1042-A, Venezuela, Phone 014-264317, Fax: 58-2-6930629

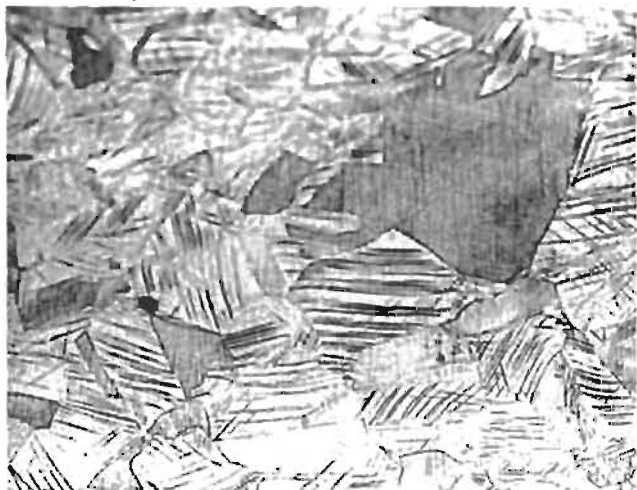
Figure 1a

numerous deformation bands and annealing twins, as it can be observe in the photomicrograph presented in **Figure 1a**. A small amount of inclusions was detected (**Figure 1b**) and hardness was found equal to 98.0 ± 0.3 HRB, according with F 56, F 138 and F 139 ASTM standards.

Figure 1. Optical photomicrographs showing the a) alloy microstructure and b) level of inclusions of the implant material.

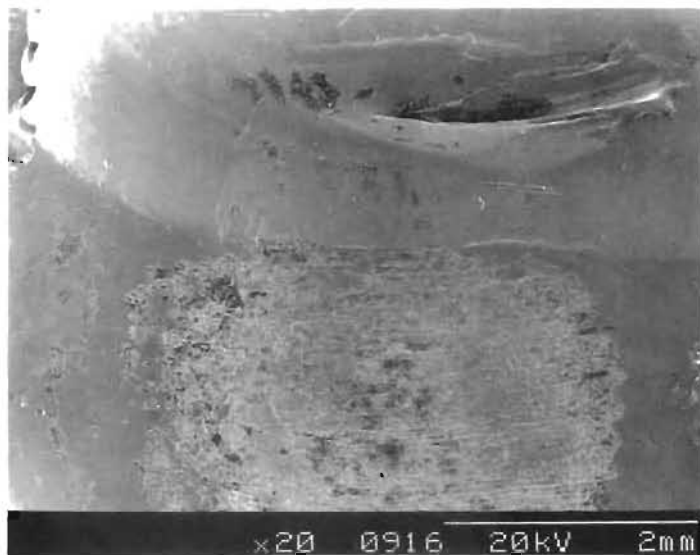
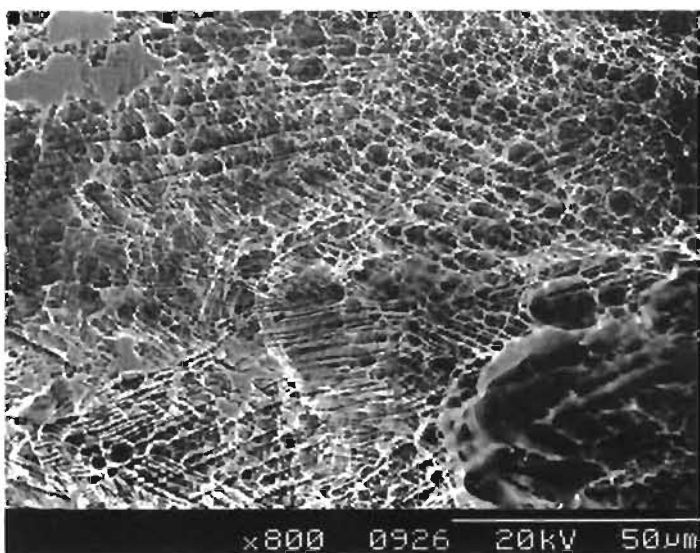
Although the plate did not failed, it presented various parts of its surface damaged, specially those corresponding to the holes, due to the contact with the screws heads. Scanning electron microscopy performed on the surface of one the oval holes of the plate had indicated crevice

corrosion evidences with a high degree of pitting as shown in **Figure 2**. Also, fretting was noticed. A selective chemical attack is observed on the slip bands which is characteristic of a highly deformed material. The corrosion products encountered were identified by EDX analysis and the results are presented in **Figure 3**.

Figure 2. Scanning electron micrographs showing crevice corrosion on DHS plate. a) 20X b) 800X

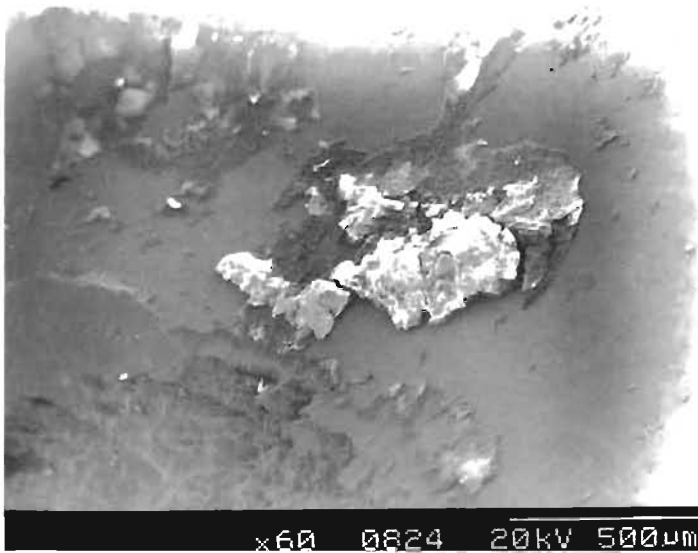
Figure 3. Scanning electron micrograph and EDX analysis of the corrosion products.

The high quantity of the corrosion products encountered on the fracture surface in **Figure 3** also supports that this screw was probably the first in braking, since the degree of the corrosion is dependent on the length of time in which the fracture surface was exposed to the environment.

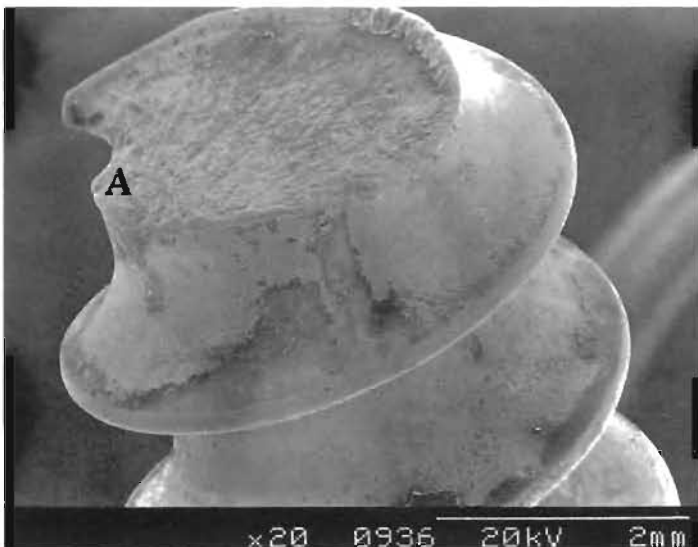
Figure 4 represents a scanning electron micrograph of the fracture surface of a cortical screw. It can be observed that the crack has progressed to nearly 90% of the area without producing an appreciable plastic deformation. In spite of the presence of apparent radial propagation lines, the examination of the samples both under the SEM and TEM revealed the existence of fatigue striations. The arrow A indicate the initial fatigue crack on the surface of the cortical screw. Fracture initiated at the surface, in the zone of highest stress concentration.

Figure 4. Macroscopic fracture cross section of the cortical screw which suffered initial failure.

The macroscopic fracture cross section shows the evidence of a brittle fracture with a very narrow shear lip. The experimental evidence indicates that this screw was probably the first in failing and its study is fundamental in determining the mode of failure. All the other screws did not present an appreciable plastic deformation, as can be observed in **Figure 5**. On the fracture surface, near to the shear lip of every screw, high quantity of pits were observed due to the crevice corrosion mechanism that occurred in the crack.

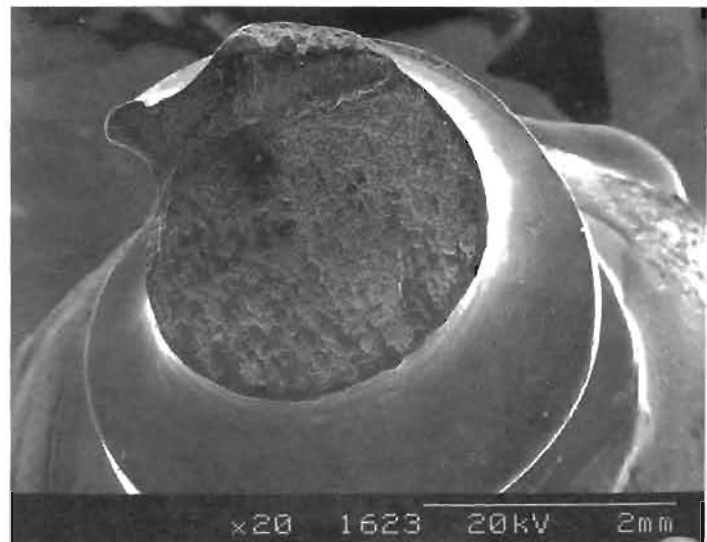
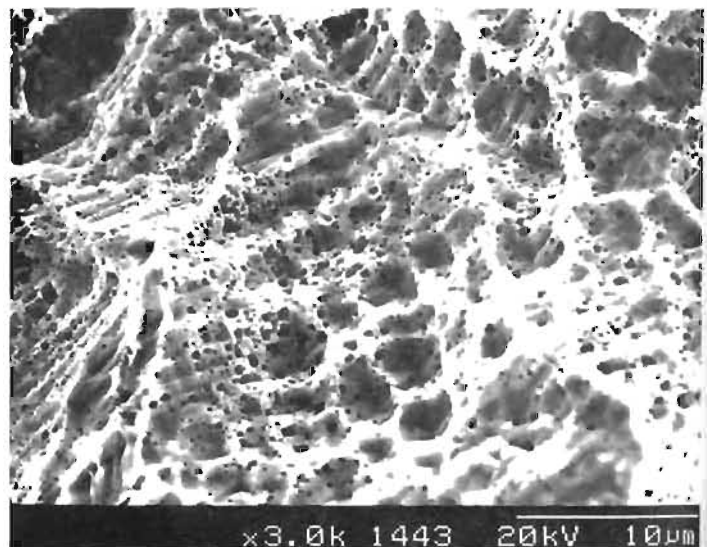
Figure 5. a) Macroscopic fracture cross section of one of the three cortical screws which had fractured presenting a brittle behaviour. b) scanning electron micrograph of the same surface fracture, nearer to the shear lip.

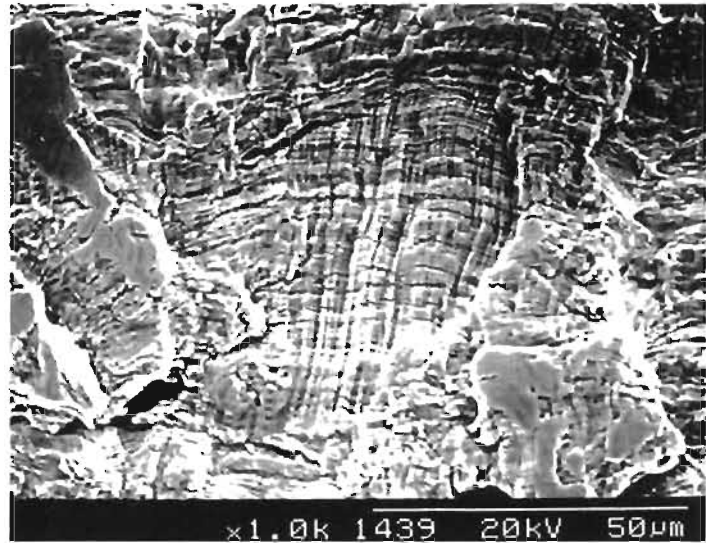
Figure 6 presents a number of photomicrographs showing typical characteristics of a fatigue process assisted by corrosion and the presence of secondary cracks. Here, again a selective chemical attack is noticed on the slip bands which are characteristic of a highly deformed material.

Figure 6. Scanning electron micrographs of the fracture surface of the cortical screw which suffered initial failure.

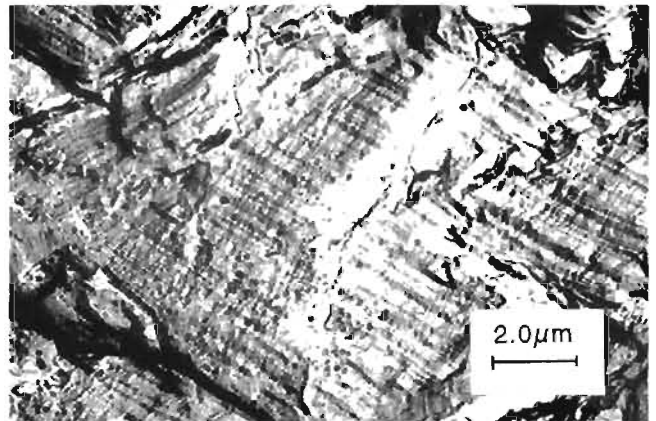
Moreover, the analysis of the two-stage replicas of the fracture surface by transmission electron microscopy demonstrated the presence of fatigue striations and a high degree of pitting as it could be observed in **Figure 7**.

Figure 7. Transmission electron micrograph of the fracture surface of the cortical screw which suffered initial failure.
