Surface Defects and Corrosions Developed on Copper Clad Aluminium Wires Investigated by Scanning Electron Microscope Analysis and X-Ray Mappings

E. Aydar ^{a*}

^a Hacettepe University, Department of Geological Engineering, Electron Microscope Laboratory, 06800, Beytepe, Ankara, Turkey.

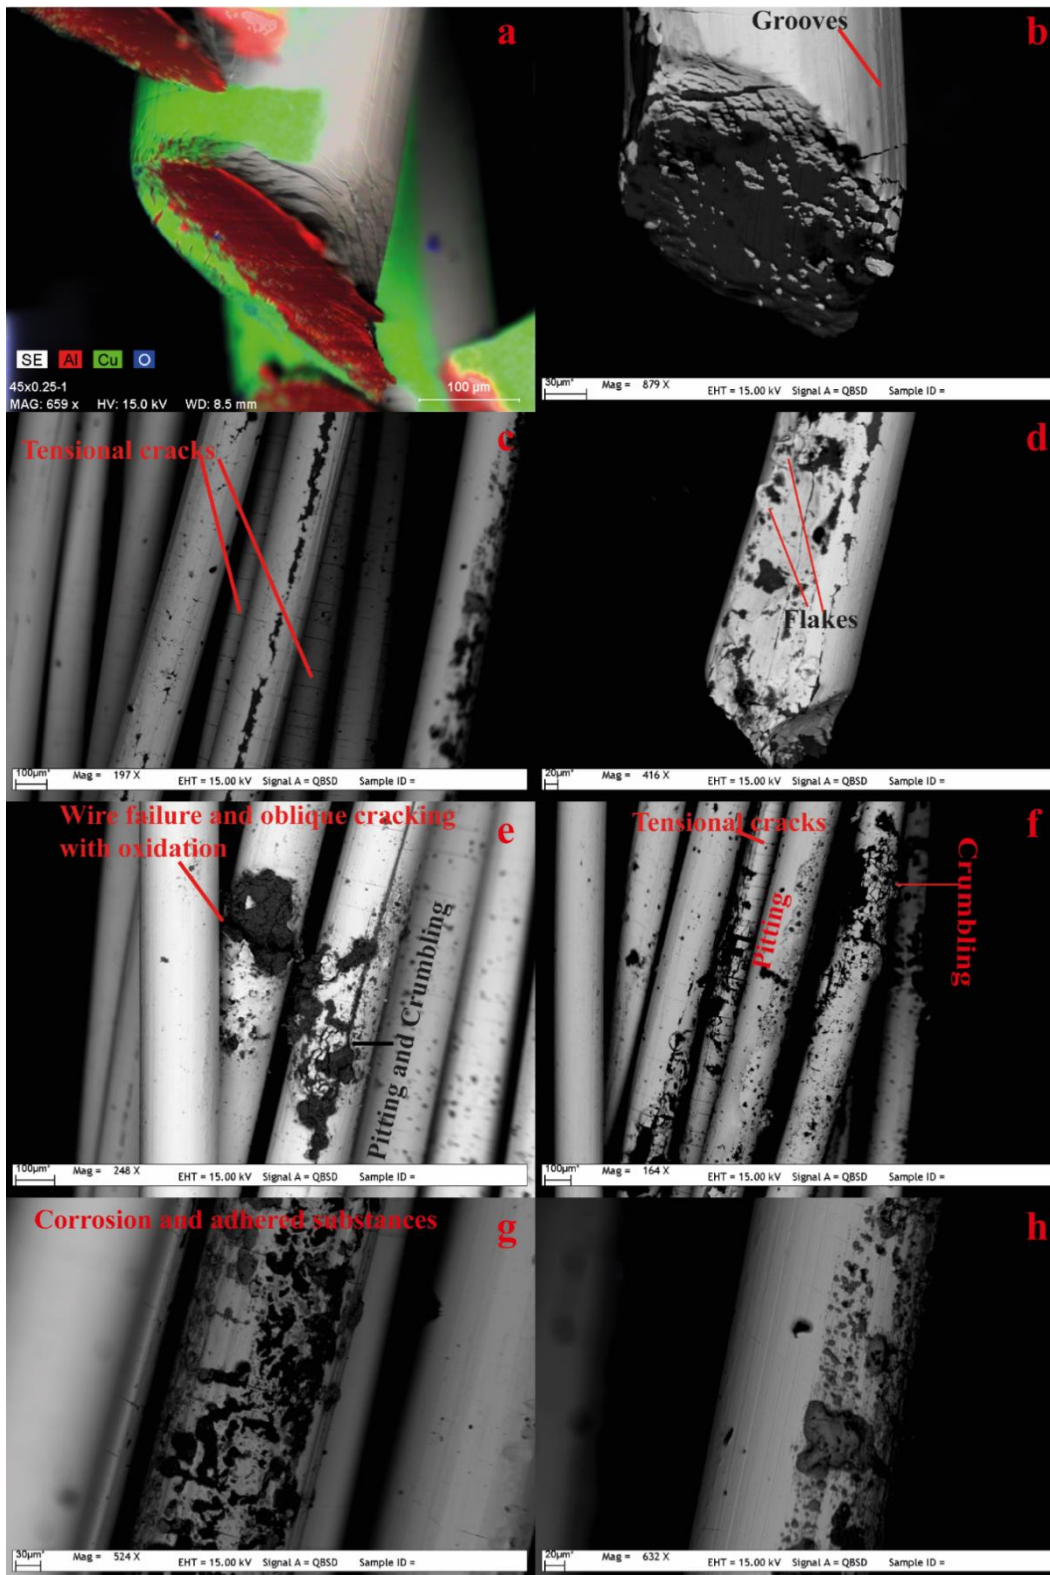
Fig. 1. Visualization of textural discontinuities, deformations, chemical substances, and corrosions in CCA by SEM study: Chemical mapping of the non-corroded section of the Copper Clad Aluminium wire; b) CCA wire with grooves; c) Tensional cracks together with other type surface defects; d) Delamination of copper in the form of flakes and tearings; e) Oblique cracking and wire failure and crumbling around the pits; f) Pits developed on tensional cracks and the grooves, and its progression is expressed by the crumbling; g) Blacks spots as the pits and adhered substances as the products of corrosion; h) The exposed side of CCA wire to electrolytic liquid expressed with the substances.

CCA wire has been visualized in figure 1a. The gray segments are not colored because they remain in the shadow segment of the detector. Color selection is entirely operator preference, and there is no genetic representation. Concentric deformation in the SE image and on the chemical mapping image (figure 1a and 1b) occurred during sample preparation with scissors. Some wires represent very regular, and continuous grooves tracked along the wire (figure 1b). These grooves create a corrugated surface that continues along the cable. In addition, very fine cracks as another textural deformation perpendicular to the long axis of wires have also developed on some wires (figure 1c, 1e, and 1f). The cracks are not separated from each other yet and are observed as many parallel cracks.

The outer layer made of copper peels off in some places corresponding to the delamination of copper in the form of flakes and tearings. The cable delaminates (flake) in areas where dark-colored substances are dense (figure 1d). They are constantly parallel to each other. Some oblique cracks, wire ruptures, and crumbling have been occasionally

observed around the pits (figure 1e).

Some pits are also present on deformed wires (figure 1e, 1f, and 1h). The number of pits is greatly increased in areas with deformation and textural discontinuities. Besides, some crumbled deformations with random cracking have also been observed which may be related to pit corrosion (figure 1e, and 1f).

The substances have adhered to the grooves and developed over the fractures. (figure 1g, and 1h). A general impression that the corrosion has mainly happened following the groove

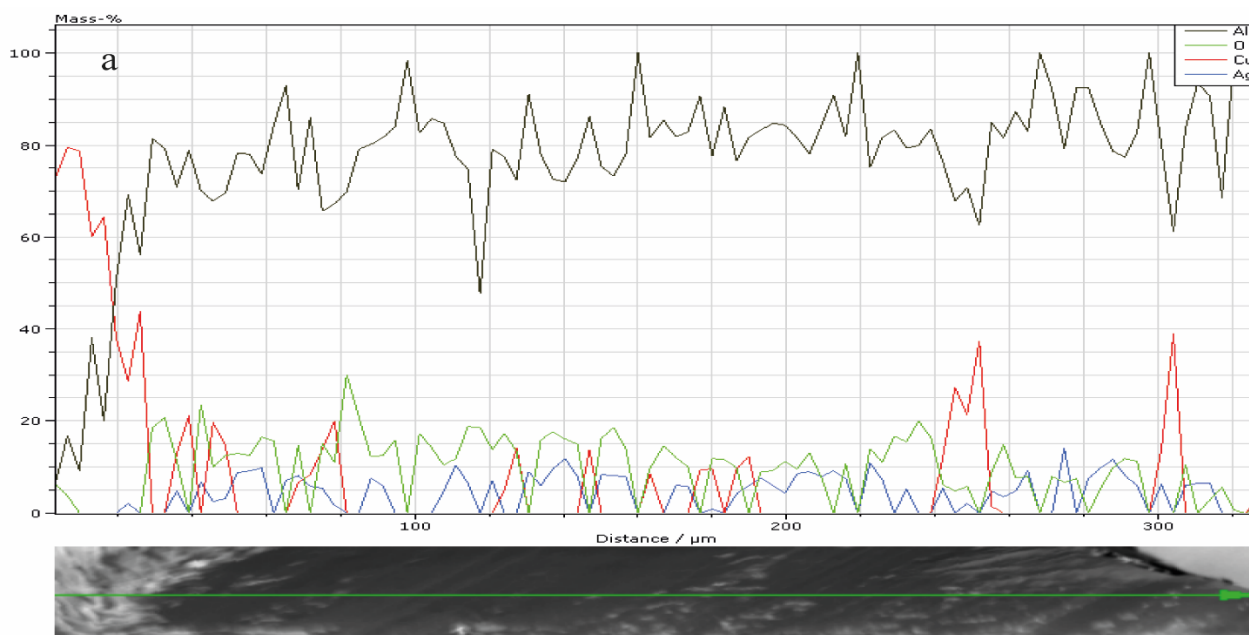
The change of chemical composition is tracked along the line shown at the bottom of the graph. Accordingly, while the Cu concentration at the cable edge reaches 80%, the Al content in the cable's center approaches 100%.

Fig. 2a. Line scan and chemistry of CCA interior (same sample as illustrated on figure 1a). Oxidation of copper is well expressed. Al appears on the black spots and other chemical substances are present in the dark area.

Besides, a qualitative chemical analysis profile, presented in figure 2a, exhibits that the non-corroded outer part of the wire consists mainly of Cu as it is expected. No other elements related to galvanic corrosion were found.

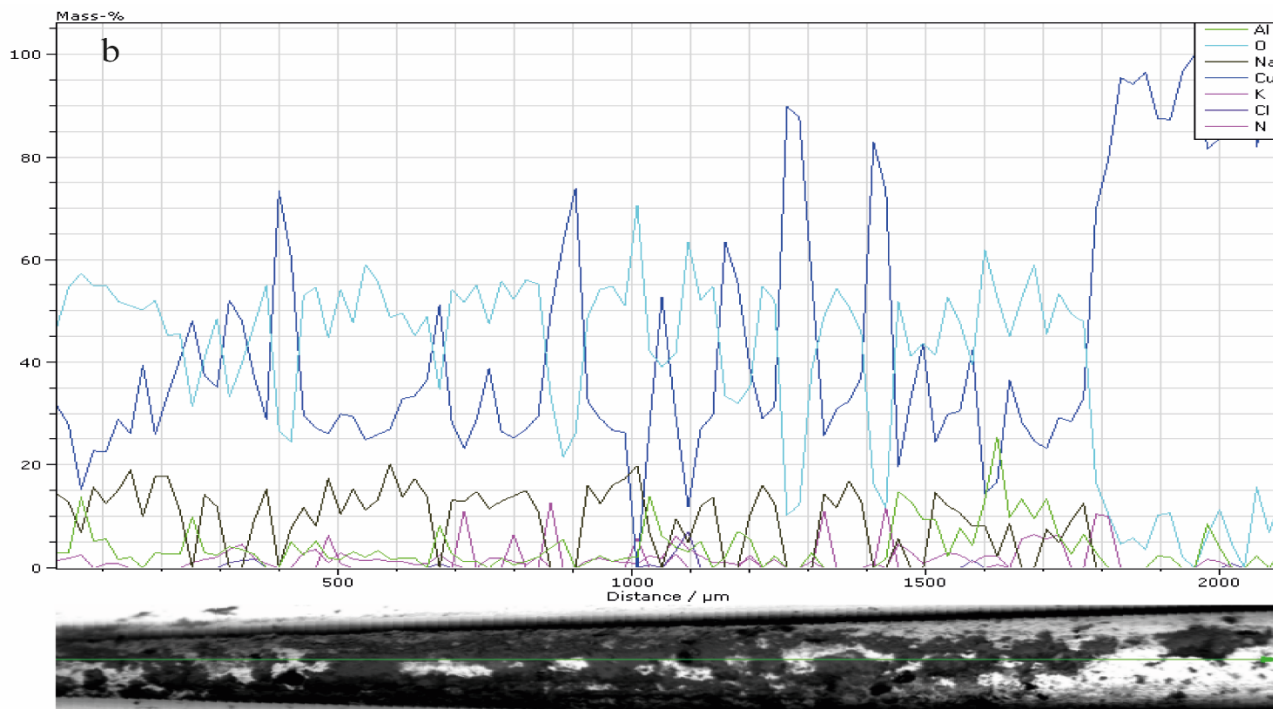
Fig. 2b. Line scan and chemistry of a corroded wire. Oxidation of copper is well expressed. Al appears on the black spots and other chemical substances are present in the dark area.

Numerous black spots on the wires appear on the general view of CCA (figure 1). Highly developed corrosion is also visualized in figure 3a and 3b. The observed dark zones correspond to the areas where the corrosion occurs and progresses (figure 2b; figure 3a and 3b).

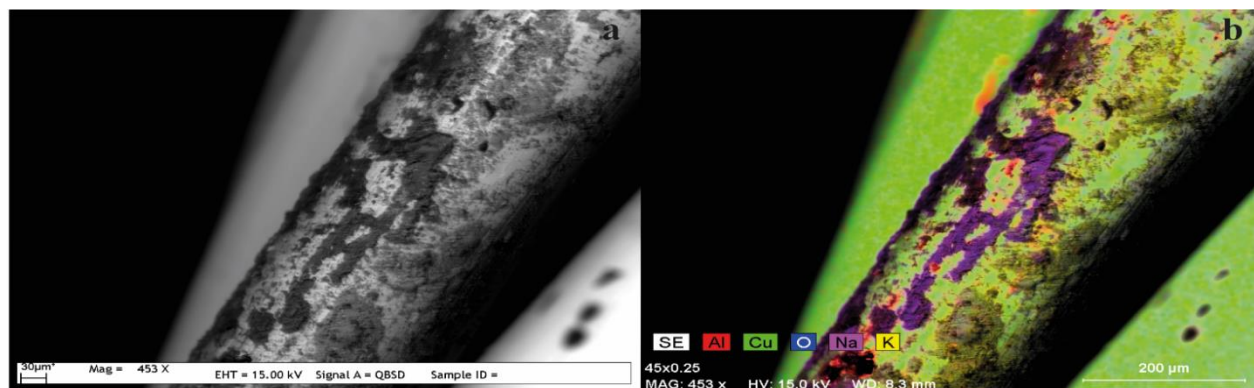
Fig. 3. a) Backscatter image of a highly corroded CCA wire with chemical substances; b) Chemical mapping of the same image.

Corrosion sometimes covers the whole cable (figure 3). Sulphurous compounds have also been detected in figure 3c on those completely corroded wires. Obviously, the corrosion and chemical substances have been emplaced along the grooves, fissures, and cracks.

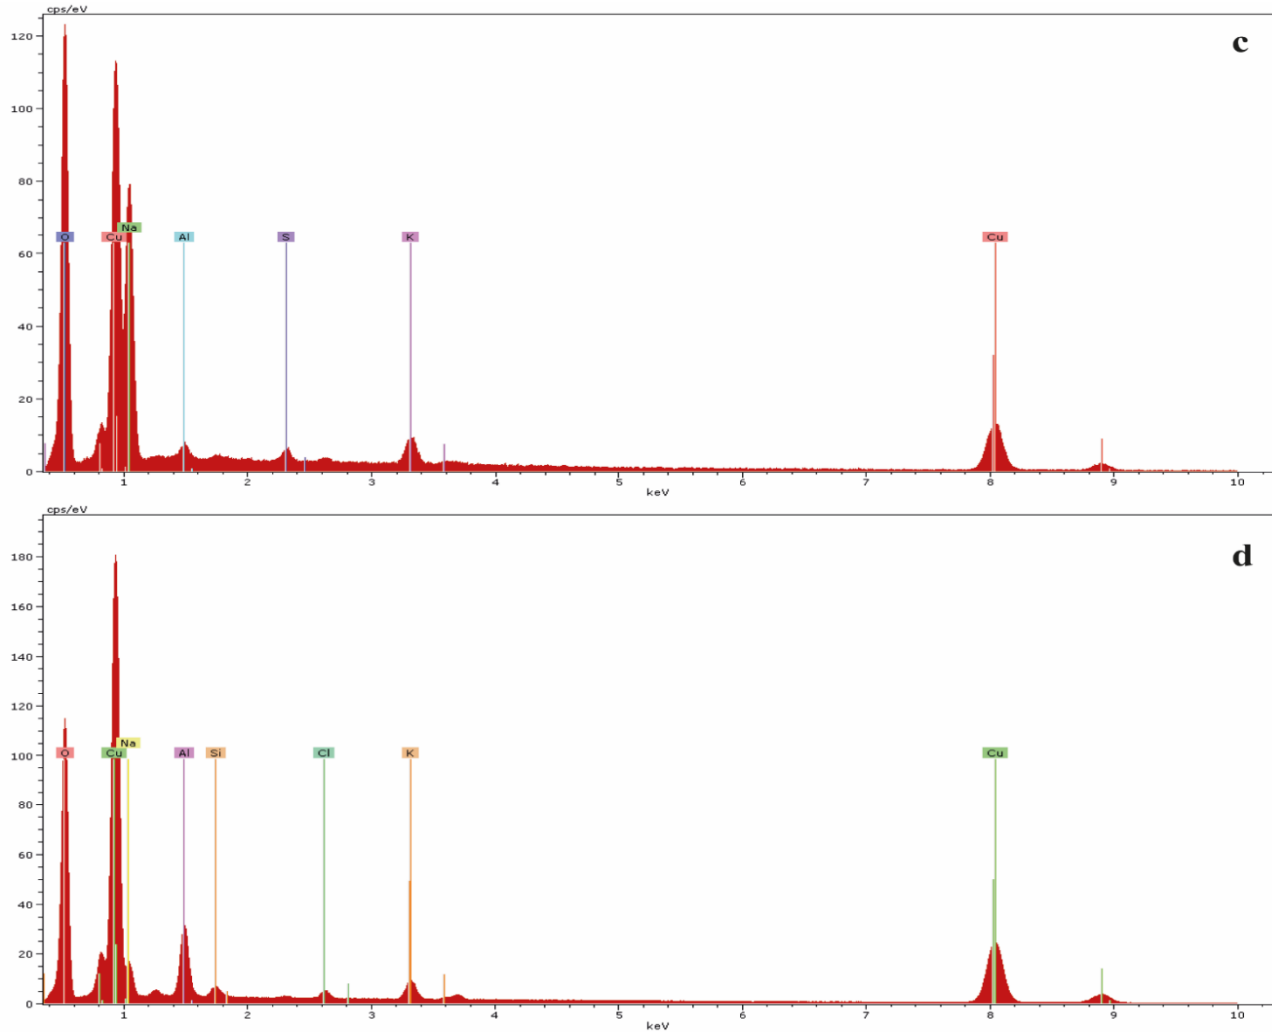
The qualitative analyses of the black spots are presented in figure 3c and 3d. They show that besides copper and aluminium, other elements such as Na, Si, K, and Cl give some peaks together with oxygen.

The high level of oxidation has also developed. The oxidation is dominant, but also exist the salt chemistry (figure 3c and 3d). The presence of many different elements besides pure metal Cu and Al indicates that the general structure is chemically degraded.

Fig. 3. c) Chemical analysis of the same cable section with line scanning; d) Qualitative analysis of the corrosion-free outer part of the wire.
