OXIDE THICKNESS MEASUREMENTS AND CHARACTERIZATION OF TWO Zr-2.5Nb PRESSURE TUBES OF EMBALSE NUCLEAR POWER PLANT

R. Bordoni, A.M. Olmedo*

Departamento Química de Reactores, Gerencia Química, Comisión Nacional de Energía Atómica. Avda Gral Paz 1499 (B1650KNA) San Martín, Buenos Aires; Argentina

ABSTRACT

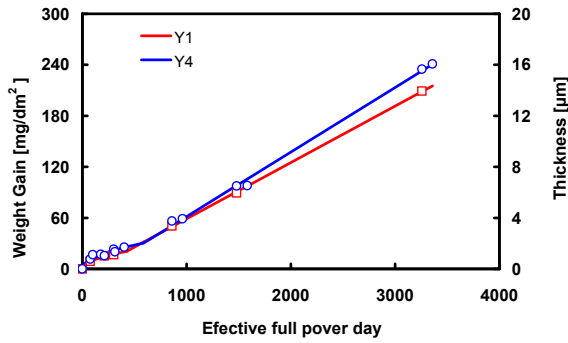
The primary heat transport system (PHTS) of Embalse NPP has two separate heat transport circuits, each one with two steam generators (SG) of the recirculating type. The system is provided with four in-line autoclaves, located out of the core in the primary coolant system, that are used to measure corrosion at outlet and inlet SG conditions (about 265 and 310°C). The coolant is lithiated heavy water, $\text{pH}_{25^\circ\text{C}} = 10.2 - 10.4$, hydrogen content 3-10 $\text{cm}^3/\text{kg D}_2\text{O}$ [13,16,18]. Different structural material have been introduced in these autoclaves since 1983, coupons of Zr-2.5 Nb machined from non-irradiated TPs were included [13,18]. The long-term studies of these materials were carried out during more than 3400 EFPD of the plant service. Figure 15 depicts the oxidation kinetics of Zr-2.5Nb of pressure tubes samples exposed during 3400 EFPD (equivalent to 9.4 EFPY) in the two autoclaves that are at around 310°C in the two loops. This Figure also shows that the oxide thicknesses of the autoclave samples are similar to those of the PTs samples at 5.8 m axial location from the inlet of the tube after 9.9 EFPY.

Fig. 15. Kinetics corrosion of Zr-2.5Nb samples cut from an unirradiated PT and exposed to the PHTS of Embalse NPP autoclaves.

Table II summarizes and compares the post-transition corrosion rates of the autoclave samples (that are at the outlet of the reactor) with the average corrosion rate at 5.8 m axial location of both PTs. The post transition corrosion rate values of the samples inserted in the CNE autoclaves are within the range of the values reported by Warr *et al.* [17] for off-cut samples also oxidized at 310°C.
