Microstructure of Coatings Obtained by High Velocity Oxygen-Fuel Spraying (HVOF)

Corrosion behaviour of 75%Cr₃C₂-25%NiCr coatings deposited on 42CrMo6 steel by High Velocity Oxy-Fuel spraying (HVOF) was investigated. Three coatings were studied; two of them using different spraying parameters (standard and optimized) and third one submitted to a thermal treatment.

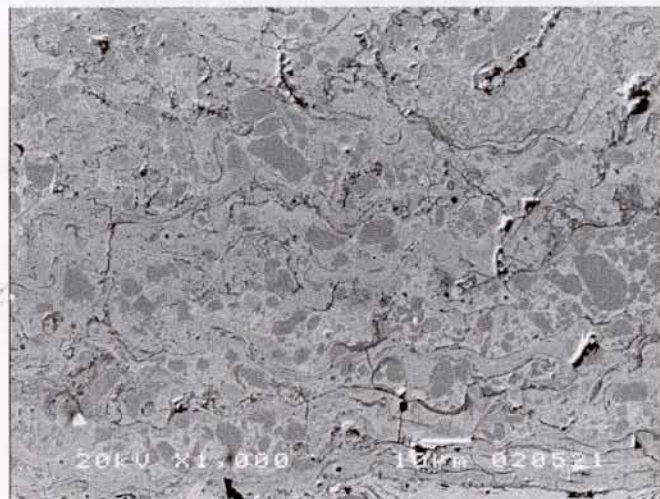
The main difference between **Q3** and the other two samples (**A** and **B**) is the presence of small cracks caused by the thermal treatment performed in such sample (**figure 2**).

Such thermal treatment performed between the spraying of the first layers and the other ones seem to have a stress-relaxation effect. Chromium oxide was also detected inside of such cracks, which were preferentially located in the layers that suffered thermal treatment and close to the substrate. The upper layers of the coating showed a structure similar to **B**, without this kind of cracks.

Fig. 2: SEM cross-section image of the thermal treated **Q3** sample, close to the substrate.

Although small cracks were detected, localized close to the steel substrate on the thermal treated Q3 sample, such cracks seem to be full of oxides and act as a stress relaxation barrier. Once the first layers were deposited and the heat treatment performed, the rest of the layers were deposited on a heated Cr₃C₂-NiCr layer, which acts as a relaxing barrier diminishing the effect of the different thermal expansion coefficient between the steel substrate and the coating itself. This is the reason why the rest of the coating (the upper layers in Q3 coating) is deposited with minor cracks and defects, leading to a coating that offers a better steel protection against the electrolyte penetration than A and B coatings.

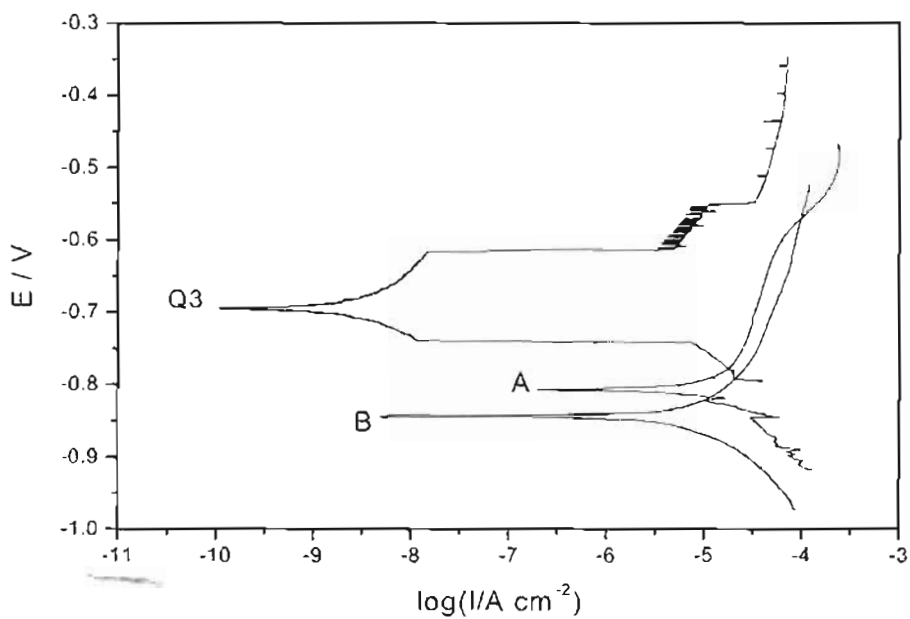
Fig. 8: Polarisation curves (CP) for A, B and Q3 coated steels in aerated and unstirred 0.5 M H_2SO_4 solution.

Figure 8 depicts the polarization curves for A, B and Q3 samples. Notice that a nobler behaviour and a low corrosion current density were observed for the Q3 sample, in agreement with the structural characterization, indicating that this coating showed a better protection of the steel against the electrolyte attack.
